Manhole Inspection Summary

Manhole # S3700_013MH

Location Address: **718 23RD ST**

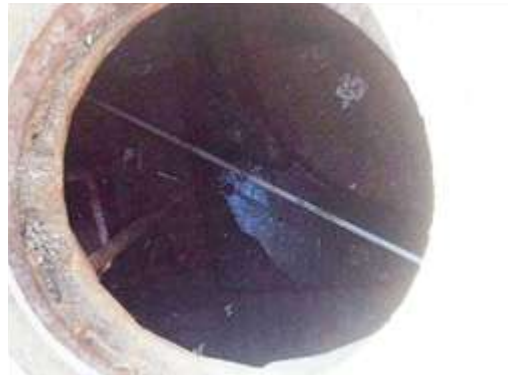
Top View

Corroded steps. Evidence of surcharge - Bench debris. Channel debris.

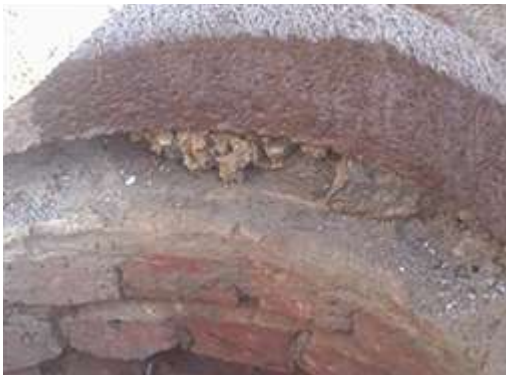
Defect

Frame offset. Adjustment deterioration and infiltration.

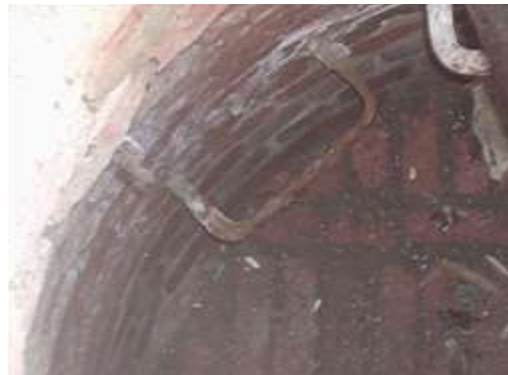
Defect

coroded step

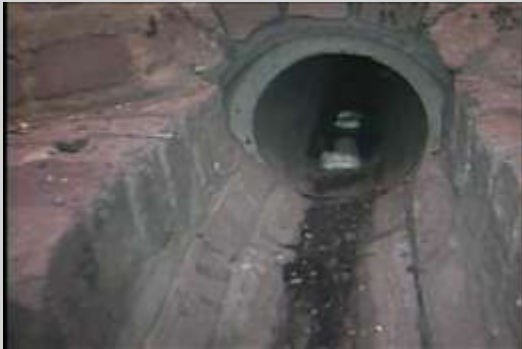
8 in. Circular Gravity Sewer Pipe Out @ 12 O'Clock

Deposits: ☐ None ☒ **Mud** ☐ Sludge ☒ **Debris** ☐ Grease

Silt Depth: **0** (in.) Deposits Extent: **Light**

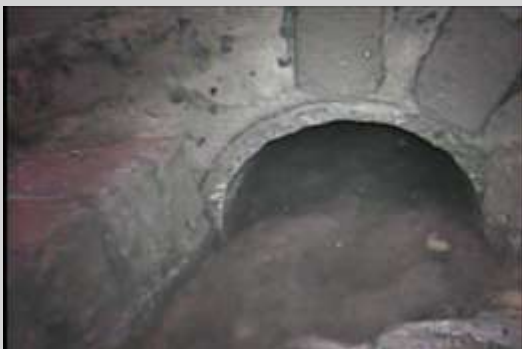
8 in. Circular Gravity Sewer Pipe In @ 3 O'Clock

Deposits: ☐ None ☒ **Mud** ☐ Sludge ☒ **Debris** ☐ Grease

Silt Depth: **3** (in.) Deposits Extent: **Medium**

Infiltration: **Evidence** Pipe Seal Cond: **Unknown**
